ADDENDUM NO. 1

CITY OF ROCHESTER, NH

PORTLAND STREET TWIN CULVERT REPLACEMENT

Wetland Report

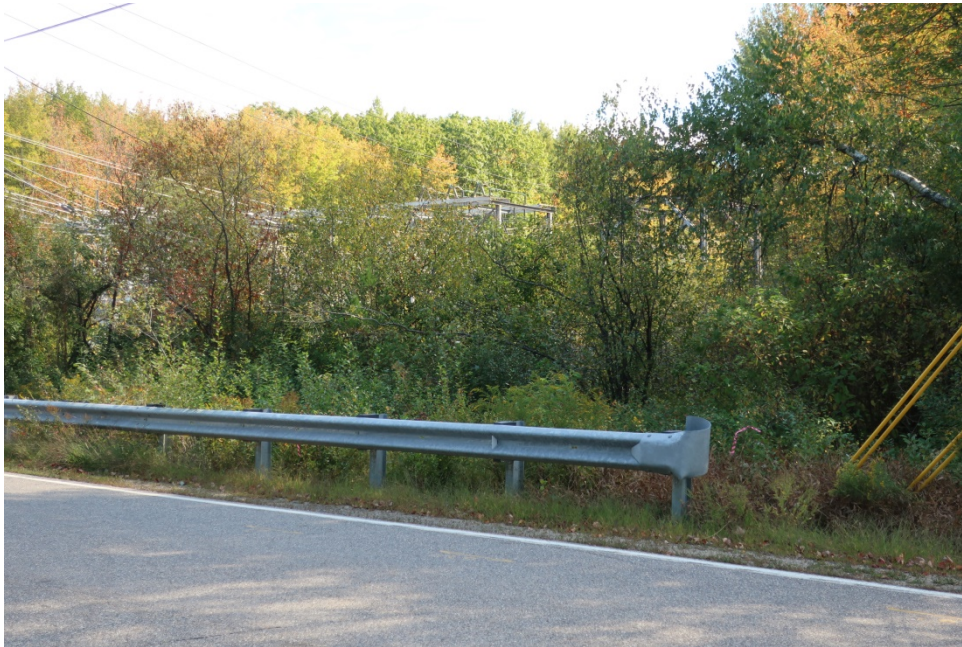
South side of Portland Street. Near culvert inlet, looking toward substation
Photo taken September 30, 2019

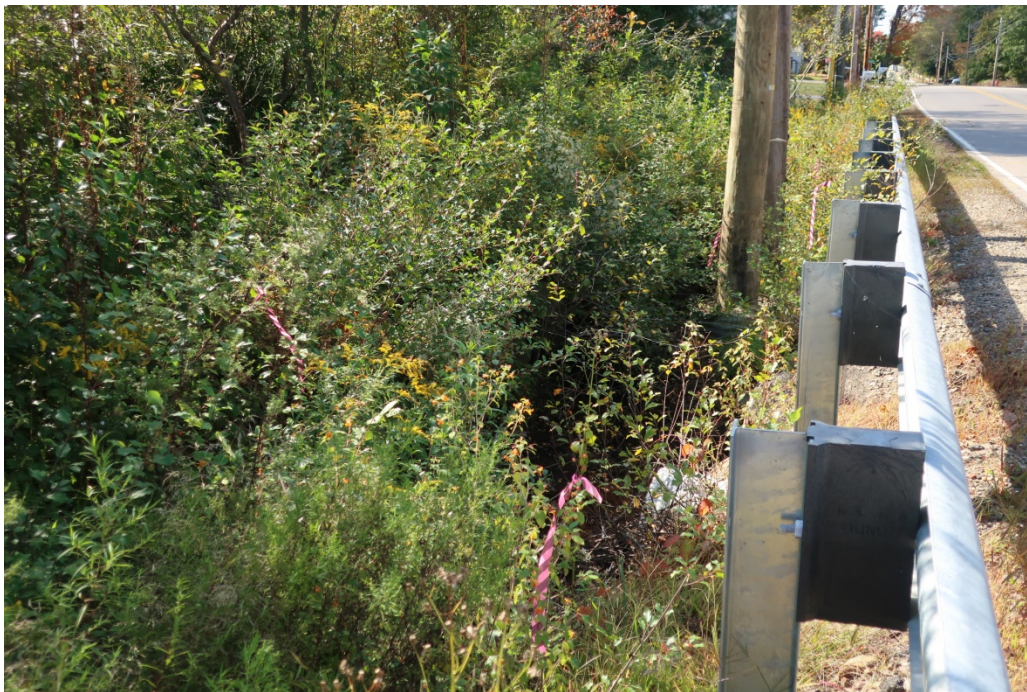
Vegetative community on the south side of road at stream outlet, looking downstream.
Photo taken September 30, 2019

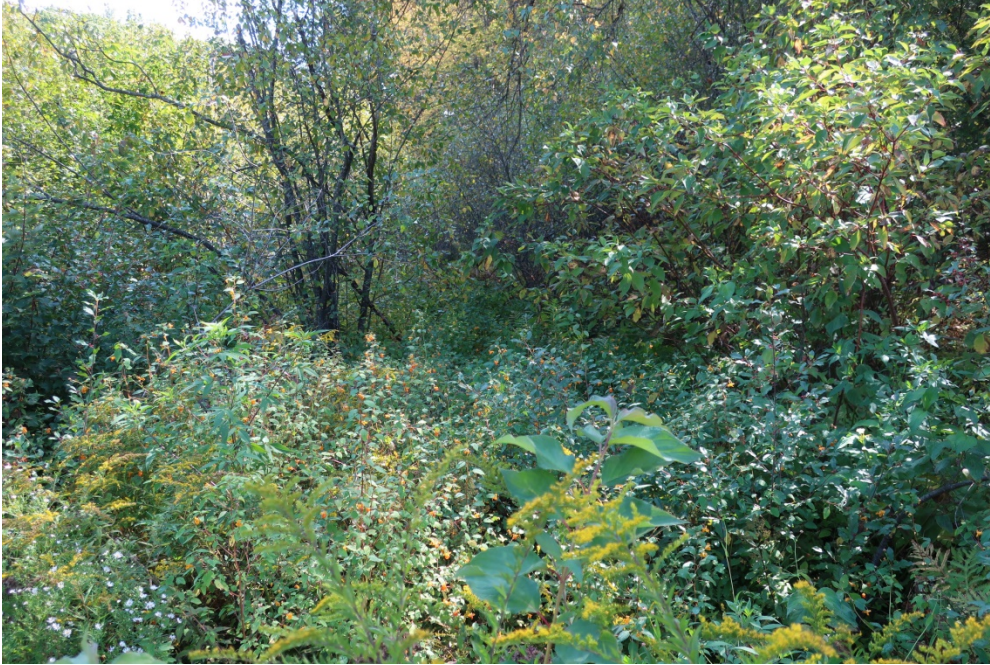
Density of vegetation within wetland on south side of Portland Street.
Photo taken September 30, 2019

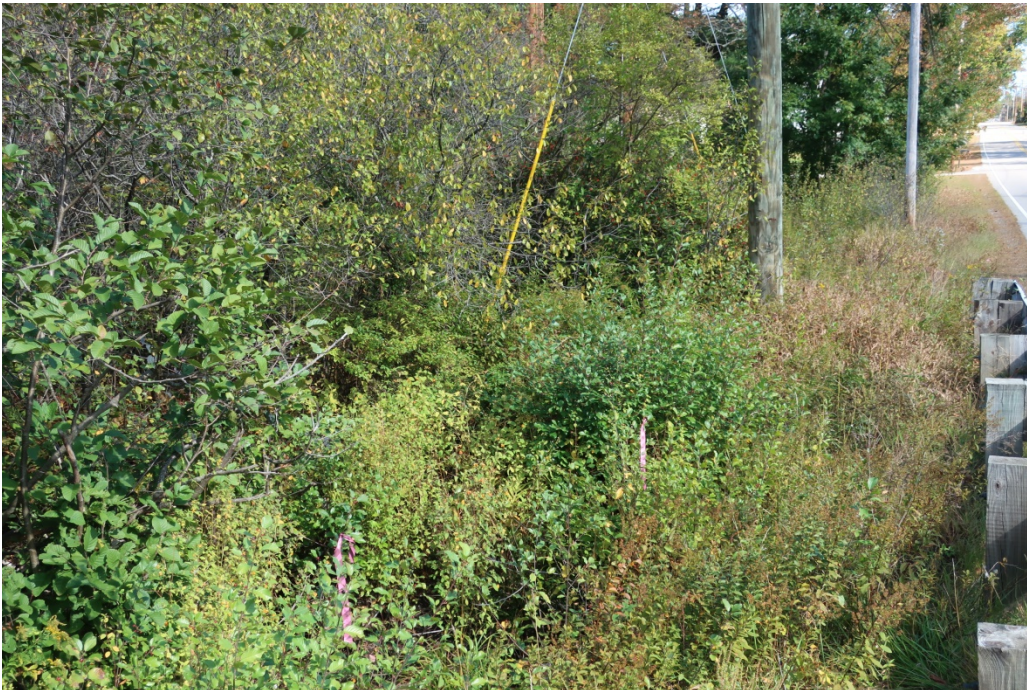
Vegetative community north side of road near culvert, looking east.
Photo taken September 30, 2019.

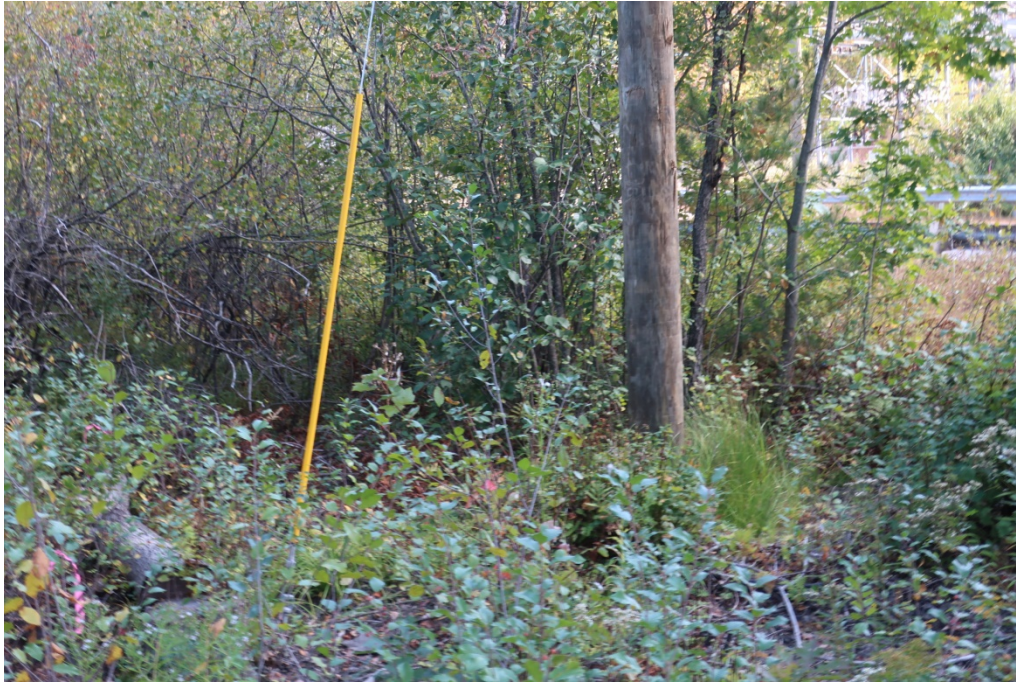
Wetland community adjacent to Flower Drive, looking southeast.
Photo taken September 30, 2019

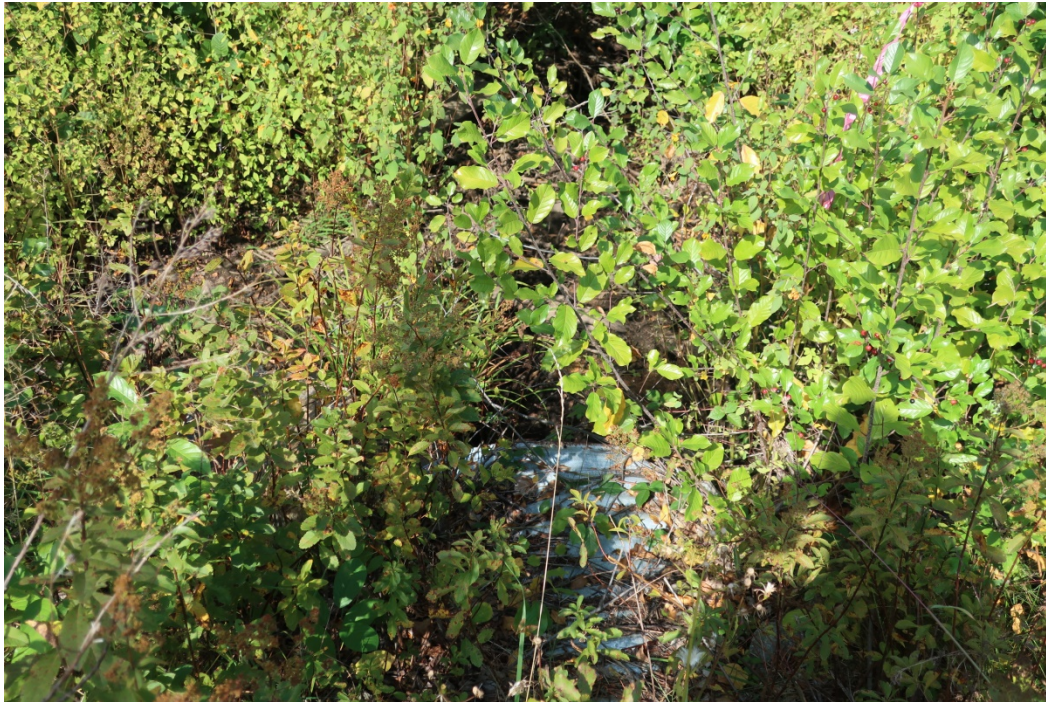
Culvert location, north side of Portland Street. Note dense shrub community
Photo taken on September 30, 2019
